PHOTOGRAPHIC INTELLIGENCE MEMORANDUM

KIOUSIN DOCKS, SHANGHAI, CHINA

This report presents the results of photo analysis of the area known as KIOUSIN DOCKS, Shanghai, China (32°12°15"N-121°29'30"E).

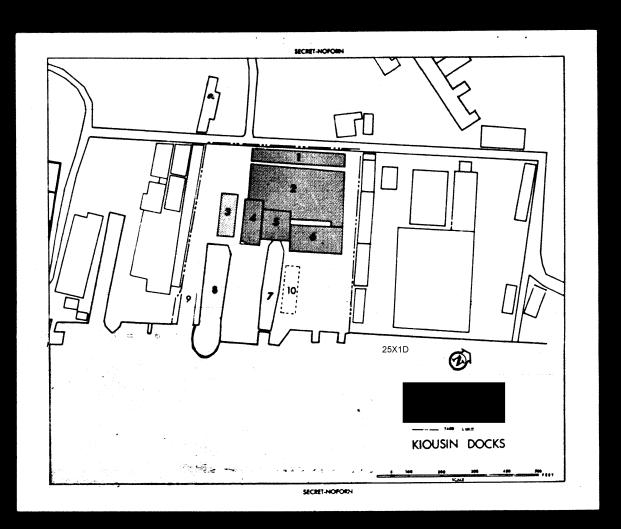
The Kiousin Docks, Shanghai are located on the West bank of the Huang-P'u-Chiang between the Sun Dah Flour Mill to the south and the Tung Chang Cotton and Oil Mill to the north. The yard is approx-imately 500 feet wide and 600 feet in depth. For additional detail see map, Annex 1 to this report.

Buildings and other installations as shown on the attached map, purposes and their sizes are as follows:

Two small marine railways have been replaced with a single marine railway (item No. 9) that is capable of handling vessels at least 190 feet long. A second graving dock (item No. 8) is under construction in an area formerly occupied by two small marine railways. Completed length of this dock will be approximately 250 feet.

A third graving dock may be under construction as indicated at Item No. 10 on the Annex to this report.
